PROBLEMS WITH YOUR MARK II?

THE CONTINENTAL MARK II RESTORERS GUIDE

BUDDY E. HOLIDAY

August 1, 1975

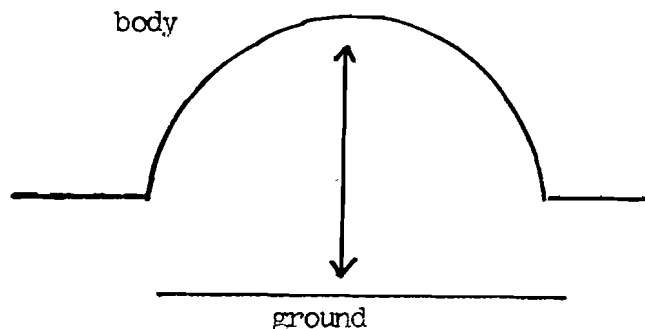
Measuring from the bottom of the fender and the quarter panel (the wheel opening) at the top of the wheel opening to the ground surface, the correct distance should be 26 1/2 inches front and rear. The following are the measurements taken from six Mark IIs, one with new springs on the front (67 T. Bird cut down).

FRONT	REAR
24 1/2	25 1/8
24 3/8	26 1/4
26 3/4	28
25 3/4	26 1/8
26 1/2	26 1/4
26 1/2	26 1/16

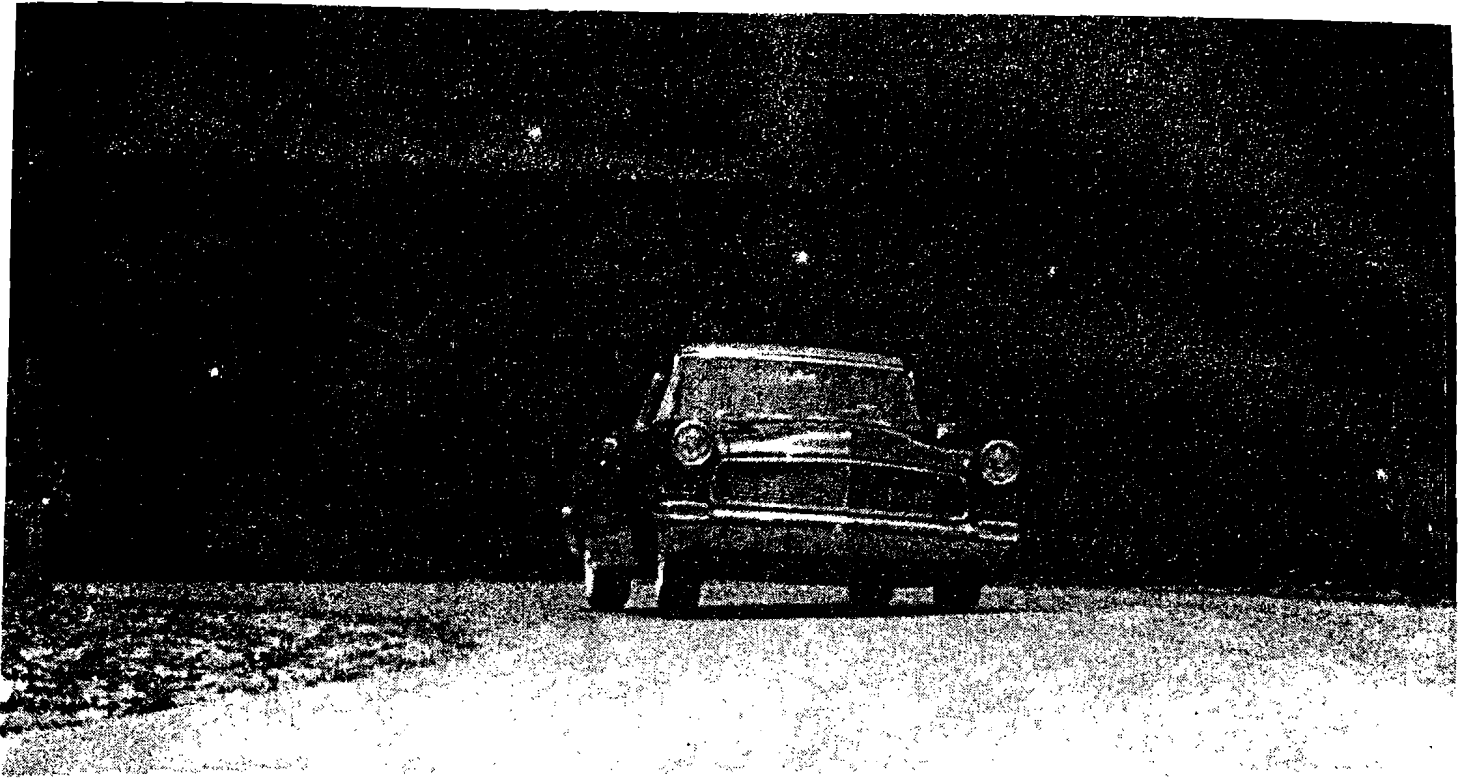
Continental on a moderate corner shows slight body lean to the camera. Its handling and ride are unusual for a car of its size.

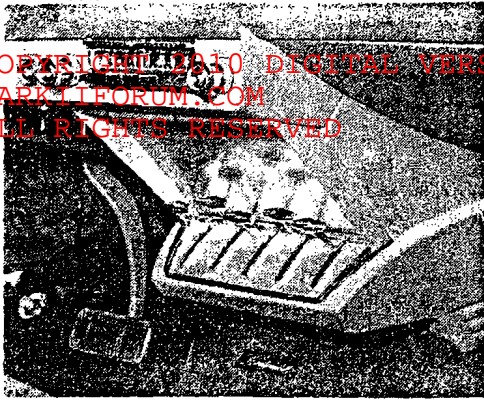
Glimpse of things to come as Continental's controls move to pedestal-type hump—a feature on many dream cars.

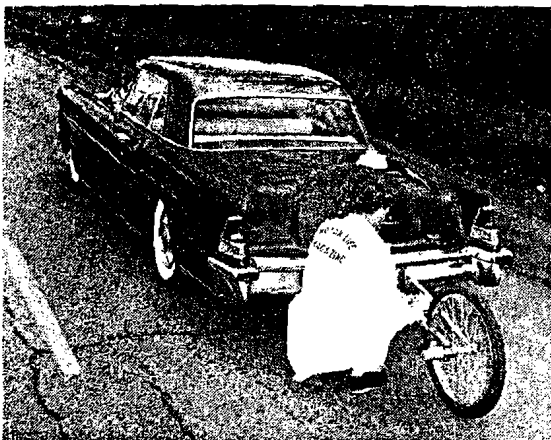
Fitting 5th wheel to car was problem, since rear bumper fits to body without normal gap. Metal meets metal in lip.

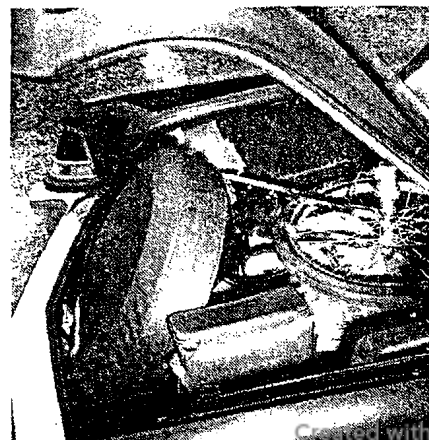
Spare in trunk leaves minimum of luggage room. Compartment that it could use moisture

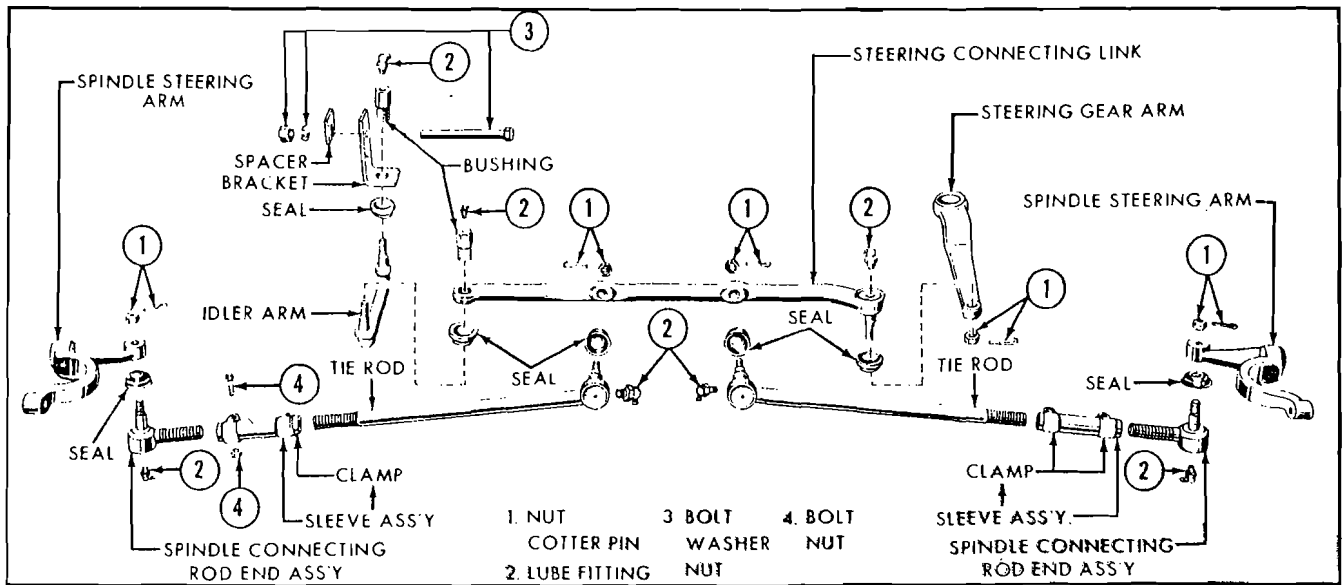
-Steering Linkage Assembly

The steering connecting link (drag link) became obsolete June 1975. Idler arms are no longer available as are the upper and lower ball joints. If you are lucky you may find a supply house that has idler arm rebuild kits.

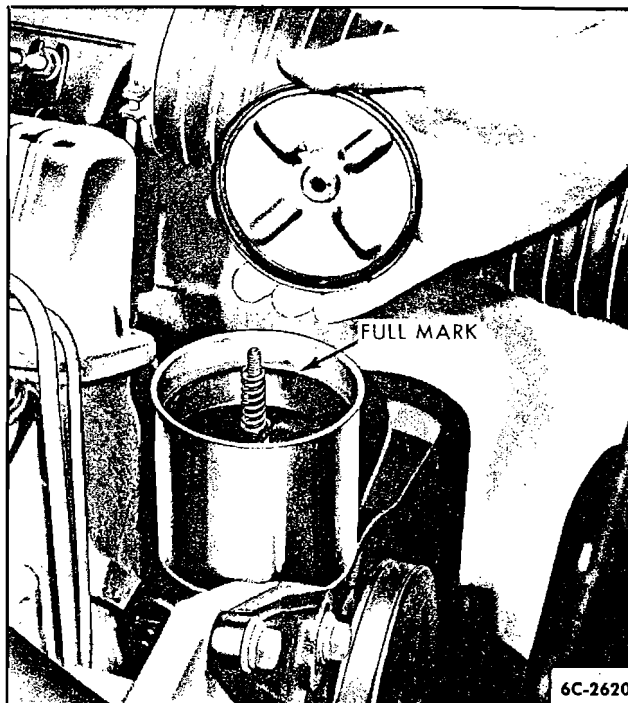
Fig. 10—Power Steering Pump Reservoir

10. **REAR AXLE HOUSING.** Check lubricant level and add if required. Clean filler plug and surrounding area before removing plug. Lubricant level should be maintained at filler hole opening. Use lubricant LA-19581, S.A.E. 90, winter and summer.
11. **POWER STEERING PUMP RESERVOIR.** Check fluid level and add as required to bring up to "full" mark. Use automatic transmission fluid type "A", part number 8L-19582. See figure 10.
12. **BRAKE MASTER CYLINDER.** Check fluid level and add if required. Correct level is 1/4" from top of filler opening. Use hydraulic brake fluid, part number HACA-19542. See figure 11.
13. **EXHAUST THERMOSTAT VALVE.** Apply lock fluid, part number B4A-19587-A, or penetrating oil with graphite mix, to shaft bearings with
14. **BATTERY.** Check electrolyte level. Level

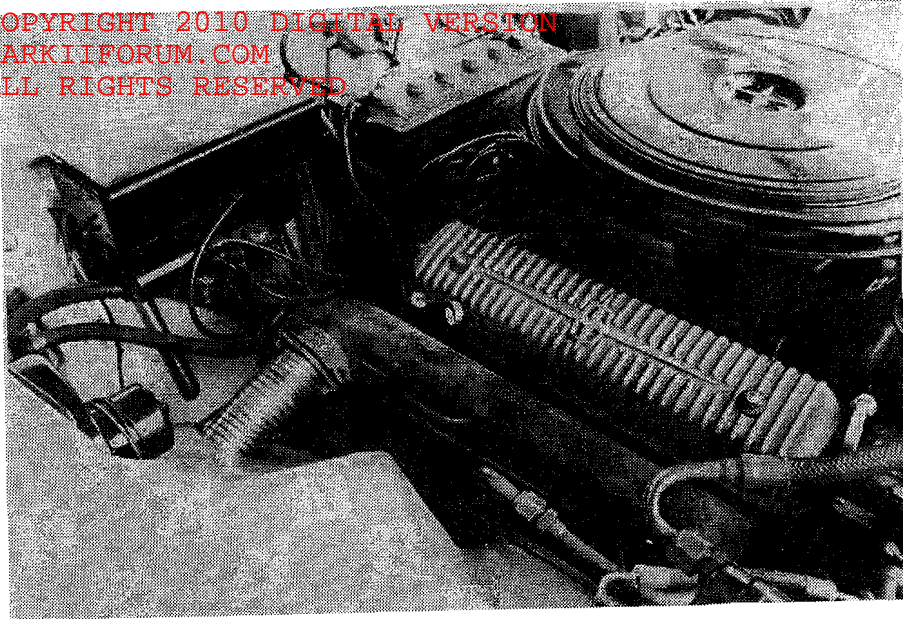
Note the stainless steel exhaust tubing and the location of the air cleaner decal.
